# Manhole Inspection Summary

Manhole # S45C\_\_061MH

Insp Date: **8/18/08 12:00 PM**

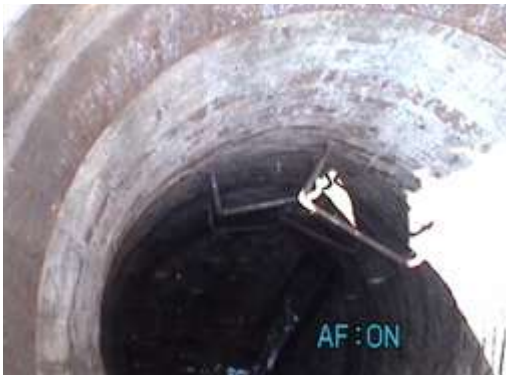
Defect 2

Infiltration: ☐ None ☐ Joint ☐ Cracks ☐ Mortar ☐ Roots ☒ **Wall**

Infiltration

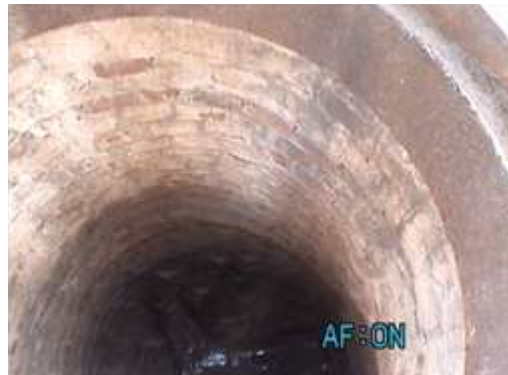
Defect 1

☒ **Leaks**

Frame Leaks

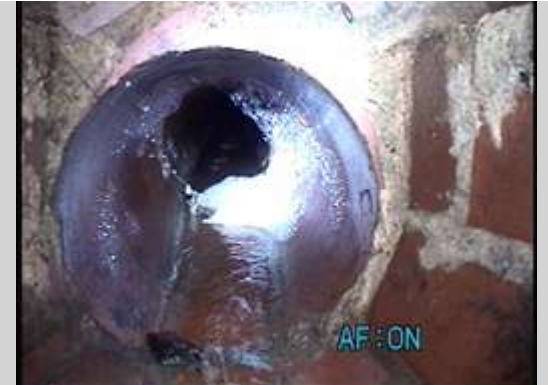
12 O'Clock Outflow

8 in. Circular Gravity Sewer  
Pipe Out @ 12 O'Clock

Infiltration: **None** Pipe Seal Cond: **Sound**

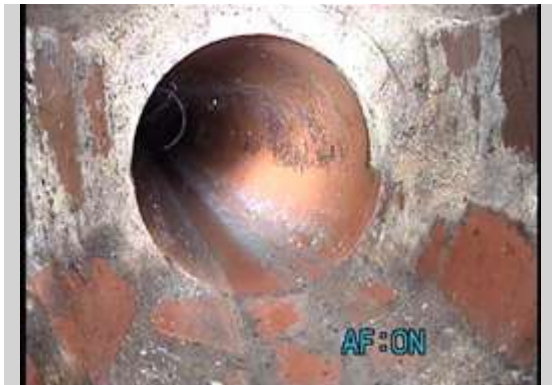
3 O'Clock Inflow

8 in. Circular Gravity Sewer  
Pipe In @ 3 O'Clock

Infiltration: **None** Pipe Seal Cond: **Sound**

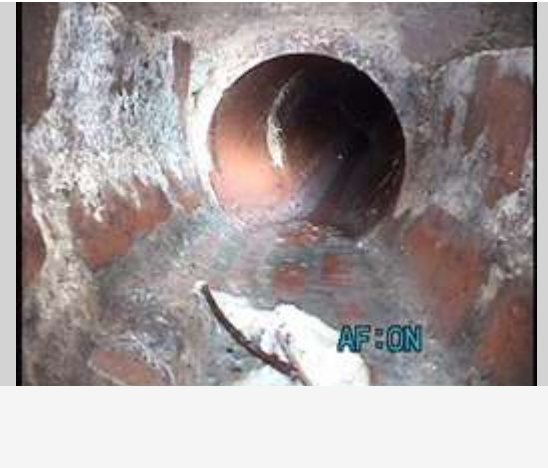
8 O'Clock Inflow

8 in. Circular Gravity Sewer

Pipe In @ 8 O'Clock

Infiltration: **None** Pipe Seal Cond: **Sound**
